MASSACHUSETTS COASTAL BASIN
GLOUCESTER, MASSACHUSETTS

WEST POND OUTLET
MA 00186

**PHASE I INSPECTION REPORT
NATIONAL DAM INSPECTION PROGRAM**

DECEMBER 1979

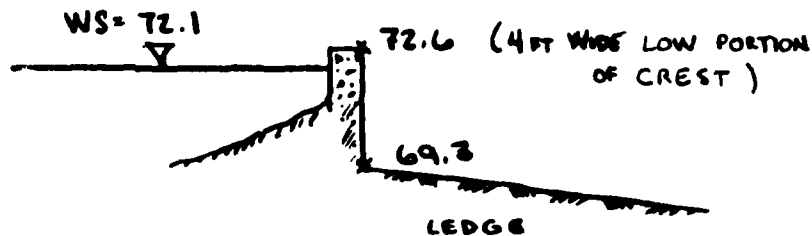
SECTION 2-2
SPILLWAY
SCALE 1 in. = 5 FT.

TREES AND BRUSH
ON SLOPE
AREAS OF OPEN,
JOINTED FIELDSTONE
ALSO APPARENT
ON SLOPE
